# Sleigh Vänersborgs Museum Konserveringsrapport

Konserveringsrapport

Sleigh conserved for Vänersborgs Museum storage by SVK Metals intern with the help of SVK wood conservator.

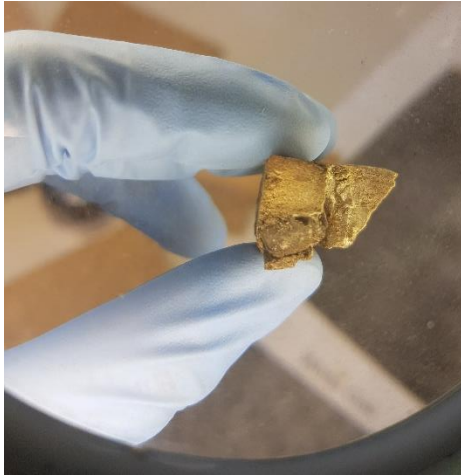
(Attempting to identify the wood)

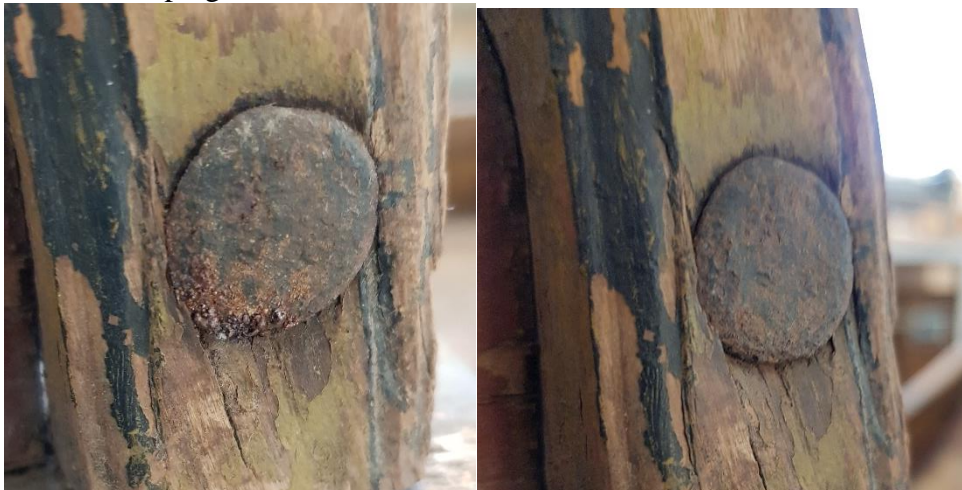
The wrought iron pieces are in a fair structural condition although some of the rivets have some weeping corrosion present caused by salt contamination and a fluctuating humidity. Additionally many of the parts are dented, likely from the sleighs functional use. Surface wise the iron parts are just as soiled as the rest of the object, covered with dust and dirt which can accelerate corrosion processes by holding moisture close to the metal.

(A rivet before and after mechanical removal of the weeping corrosion)

4. The sleigh was now cleaned with smoke sponges lifting much of the more ingrained dirt and dust.
5. Ammonium citrate 3% in water was then tested for cleaning of the paint. The paint appeared slightly soluble in this however and cleaning using saliva was instead used as it did not deteriorate the paint whilst further removing any ingrained dirt not removed by the smoke sponges.
6. Next the metal areas were cleaned using a brush with a scalpel used to flick off areas of weeping.

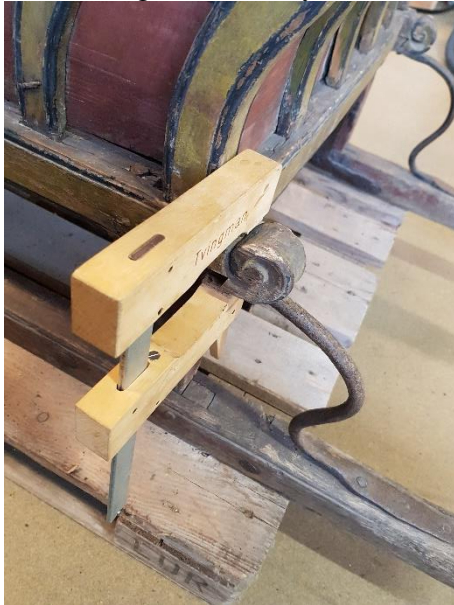
(Clamping of a loose piece whilst it re-adheres)

7. PVAC in acetone was then used to consolidate and stabilise areas where the wood was loose or such as with the piece that had been removed to totally re-adhere a piece back to the sleigh. The breakages were first cleaned with a brush and a compressed air gun. Then PVAC was applied and the parts were placed into position on the sleigh where they were clamped for more than 3 hours.

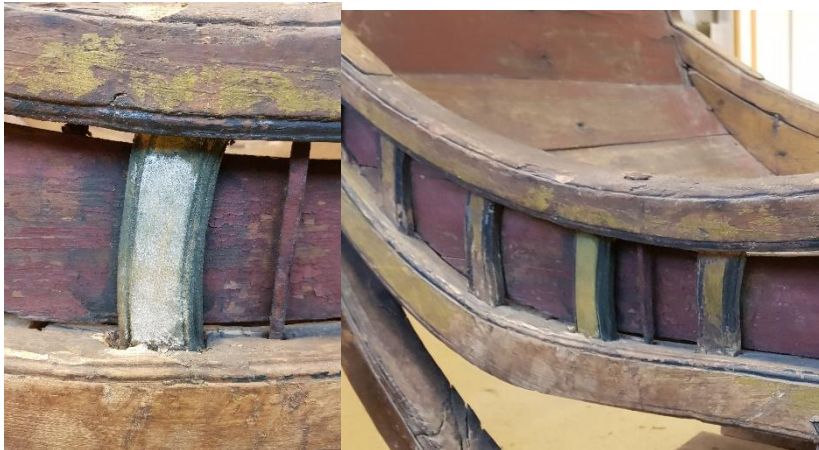
(Colour matching of some of the green wood areas)

8. Water colours were next used to darken areas where the exposed wood was very bright and distracting and in the case for the later green wood areas now noticeable after cleaning these were colour matched to the rest of the sleighs yellow and black colours.

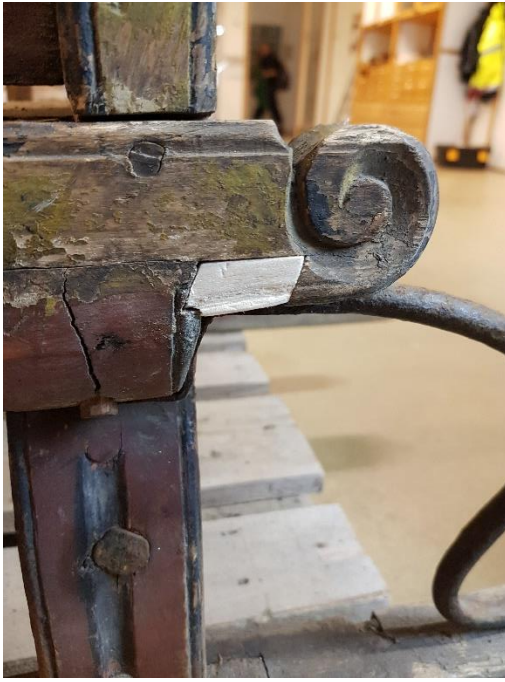
(An area of loss filled with a replacement piece made from balsa wood)

9. Some of the dowels which had over time wiggled out of their holes were hammered back in leaving them flush with the rest of the sleigh as they would have originally been.
10. For some areas of loss new dowels or pieces were made from balsa wood, placed into position, trimmed with a carving tool and then adhered with PVAC applied via a syringe, these pieces were then also re-touched using water colour to colour match them to the rest of the sleigh.

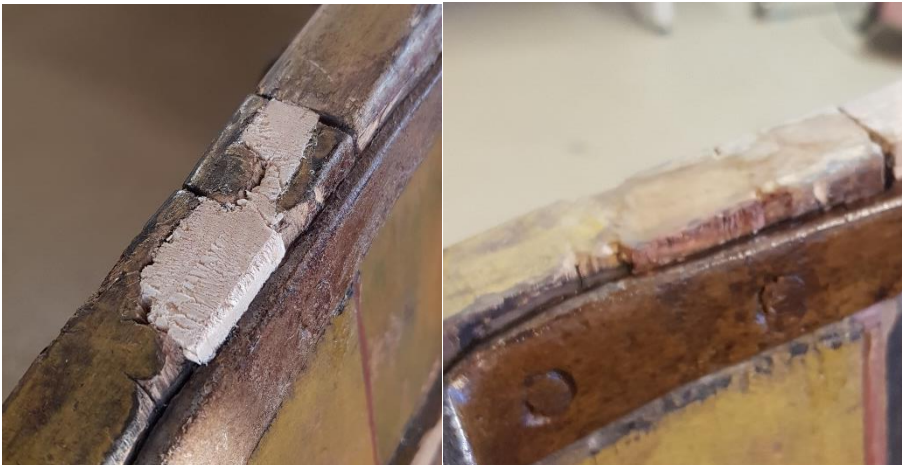
(The balsa wood fill and the fill after application of fisklimskitt and retouching)

11. An area of loss on the top of the sleigh was also filled with balsa wood, however this piece was also gap filled using fisklimskitt and then colour matched with water colours.

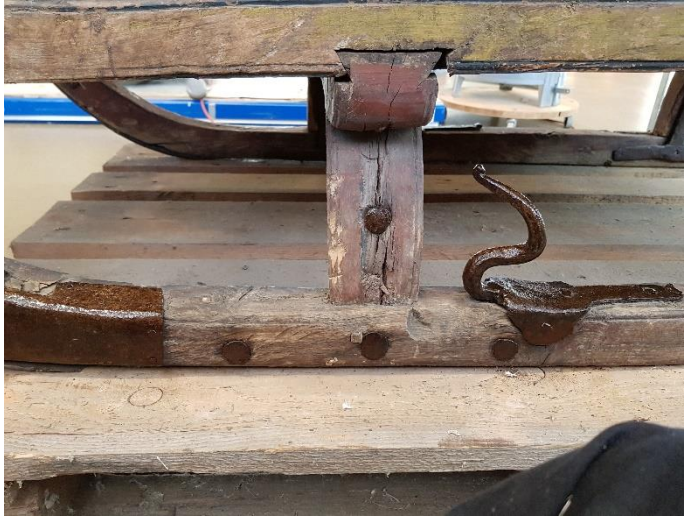
(Linseed oil lacquer freshly applied to the metal areas, after drying it becomes much less shiny)

12. One of the wooden sides which over time had warped and now no longer fit in its place was trimmed down and a small nail was used to ensure it stayed in place.
13. The metal areas were cleaned using acetone removing any of the lifted corrosion and dirt left after cleaning with the scalpel and brush.
14. Finally linseed oil, linseed oil with Aerosil 200, Regalrez and Regalrez with Aerosil 200 where tested as lacquers for the metal parts in a discrete area at the bottom of the sleigh. Linseed oil on its own gave the cleanest and least distracting finish after its long drying time so this was selected and all the metal areas of the sleigh were lacquered using it completing the treatment of the sleigh.
